Inspection Report

Give Energianlåg A/S

Work order no:	WO-791
Date started:	2022-02-15
Date finished:	2022-02-15
Customer ref no:	N/A
Engine type:	Wärtsilä 16V25SG
Generator no:	#1
Engine no:	4008
Engine speed:	1000 Rpm.
Rated power:	3079 kW.
Fuel type:	Gas
Running hours:	61 000 Hrs.

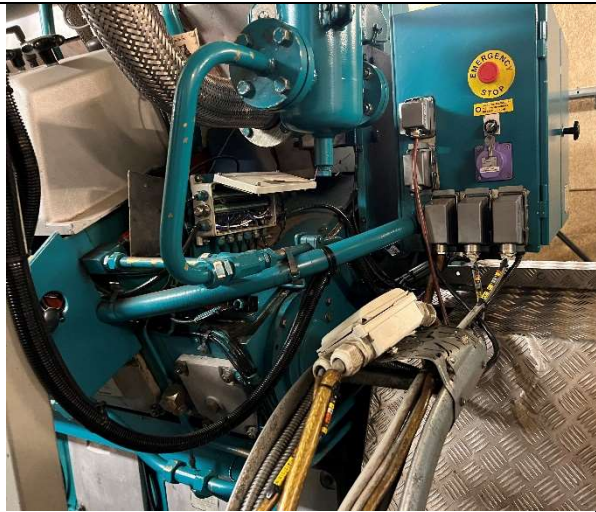
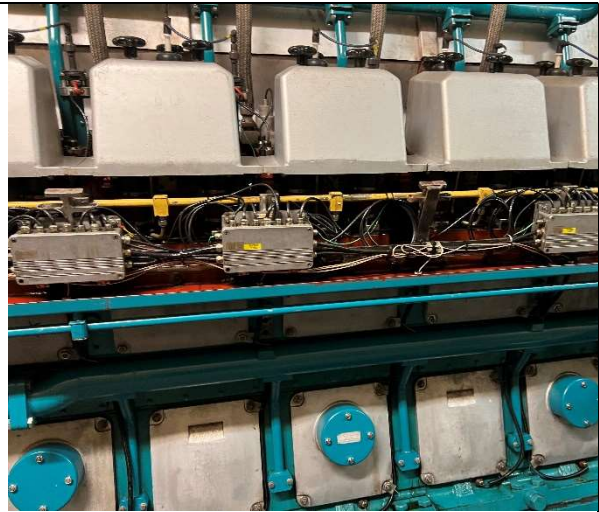
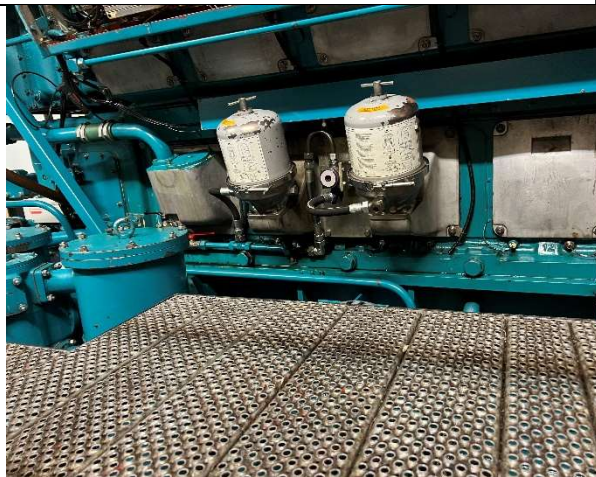
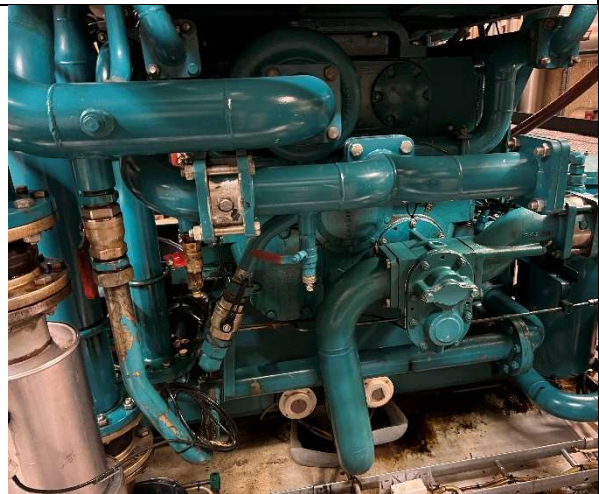
2.1 Overall condition

Engine has been in operation for approx. 61 000 hrs and condition for what you can see by a visual inspection is in general very good, when looking on overall condition it seems to be well maintained. It was not possible to make a test run as several connections were disconnected. Engine was overhauled at 50 000 hrs, acc. to report from Wärtsilä DK. At 61 000 Hrs. the MCU processor card was renewed acc. to report and invoice from customer.

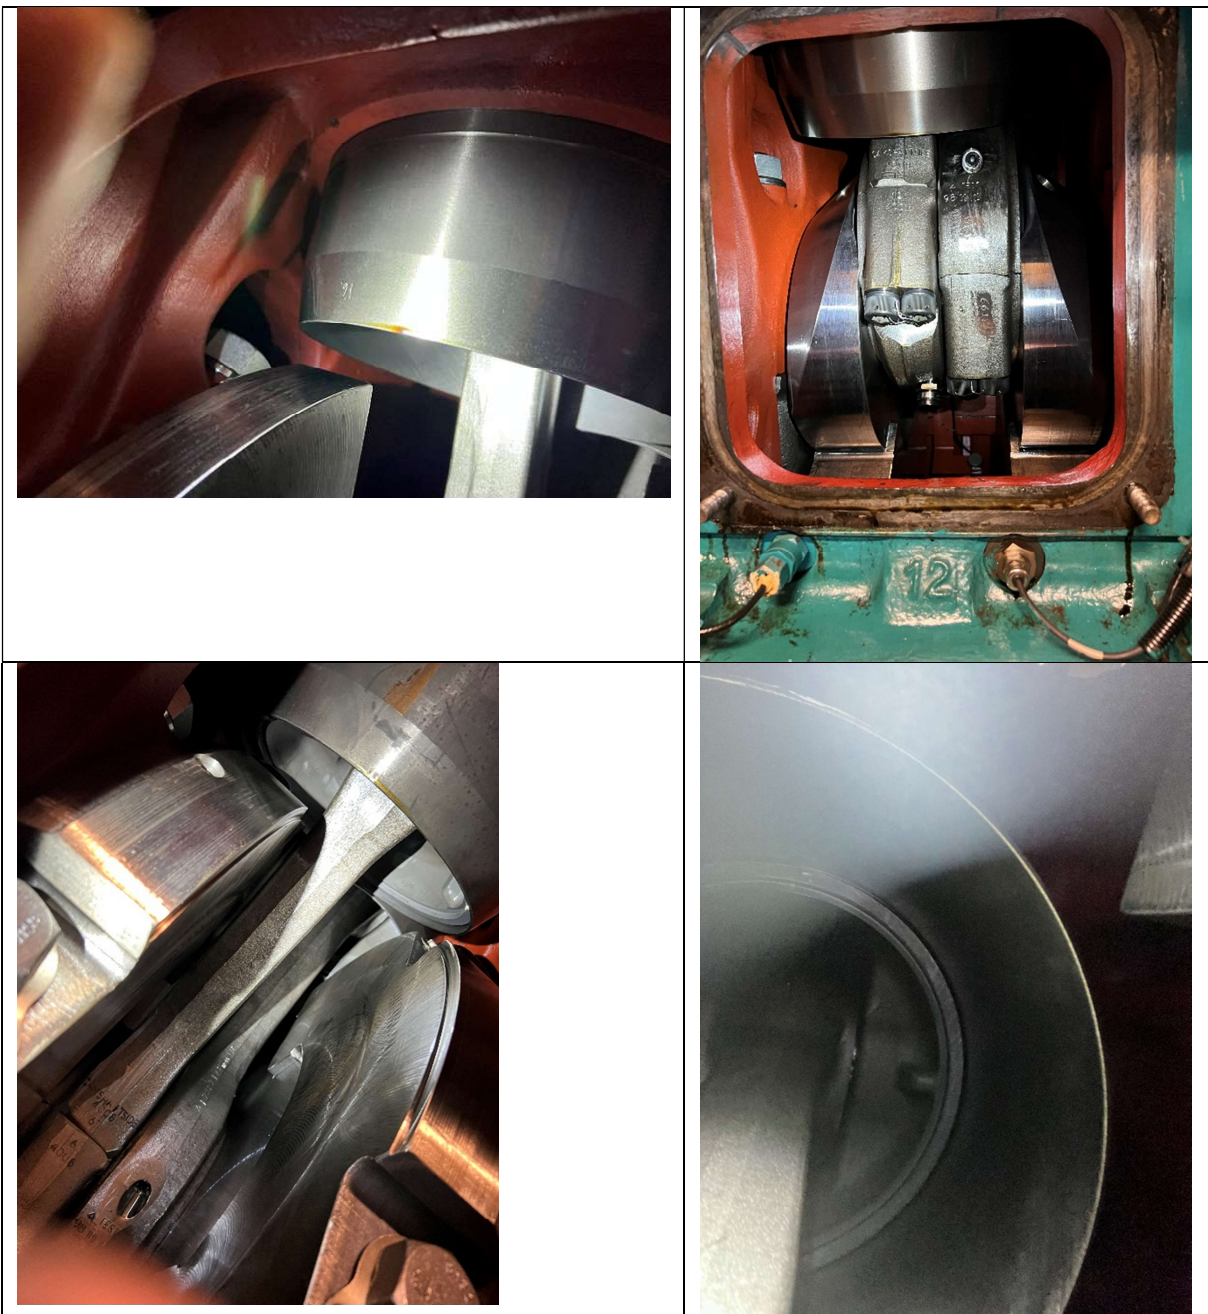
2.2 Engine block and crankcase

Engine block and crankcase were visually inspected without disassembly. All visible surfaces are in good condition and no water leakages in crankcase or around cylinders were noted.

Crankcase was very clean and honing pattern inside cylinder liners looked intact for as far as visible. Acc. to report from 50 000 Hrs. service engine block has been machined on landing surfaces for cylinder liners, distance has been compensated with shim rings between 1 and 2mm underneath cylinder liner. (This is a very common repair method on Wärtsilä Nohab engines.)

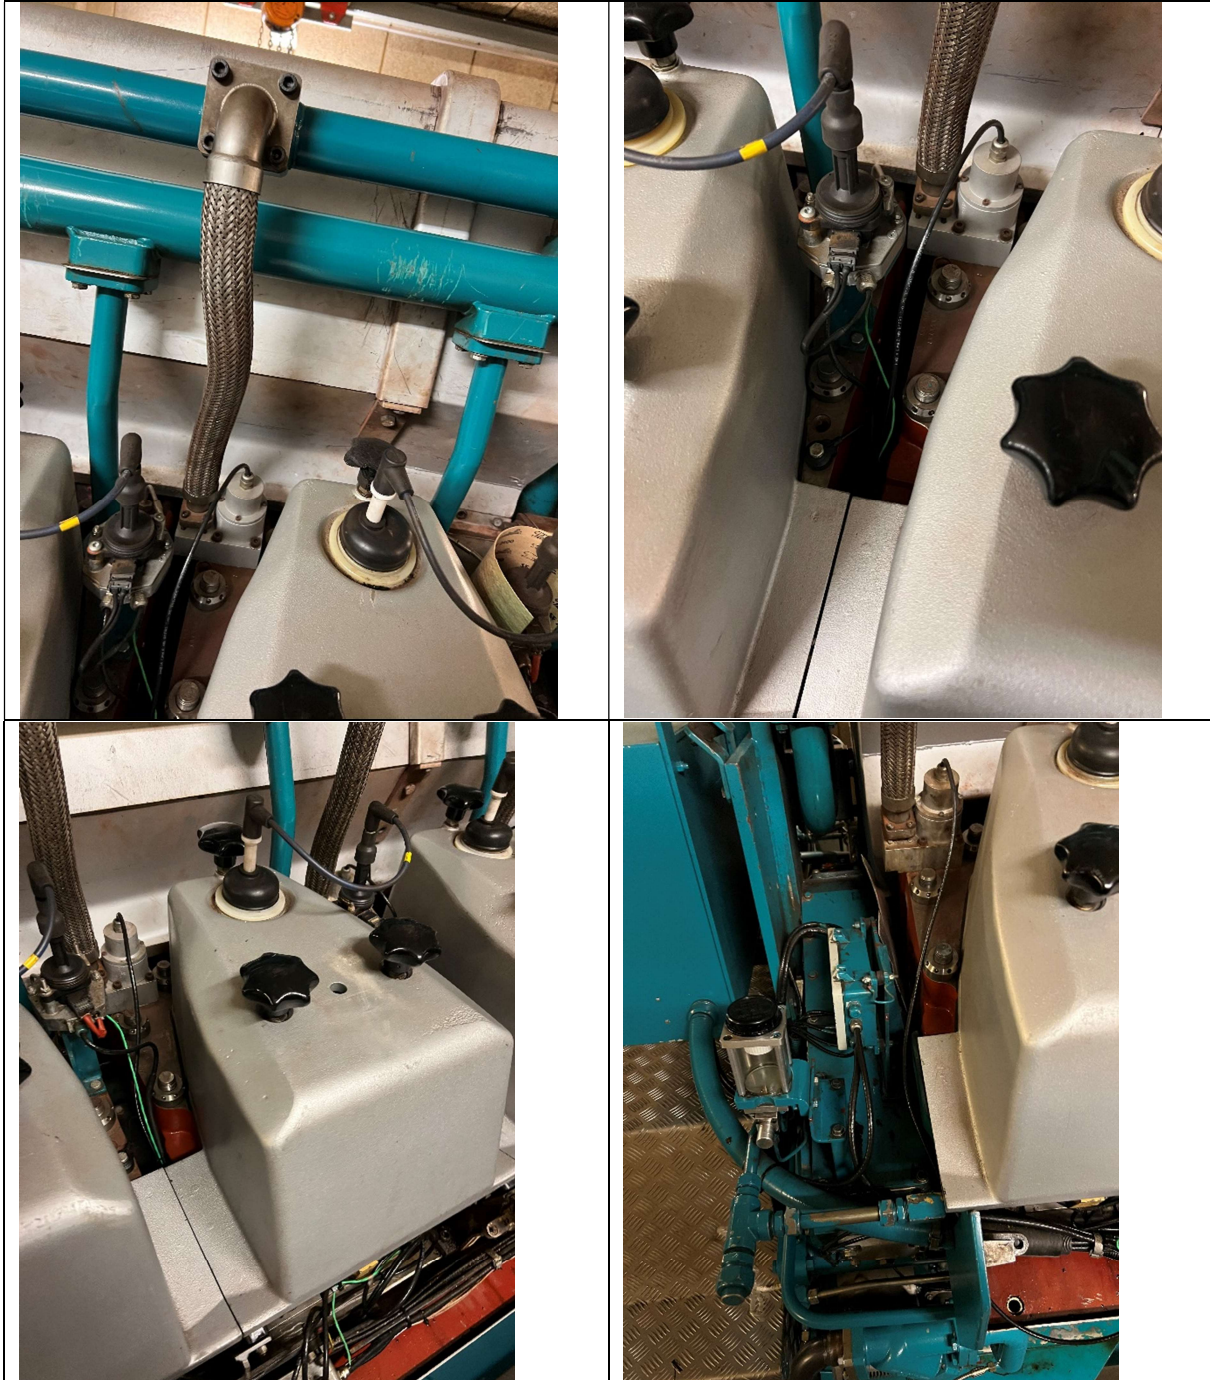
2.3. Cylinder heads

All visible surfaces on cylinder heads were in good condition, no indication of leaks from water, fuel, inlet or exhaust connection.

Cylinder heads were overhauled at 50 000 Hrs service acc. to report. No measurement reports included in report so difficult to determine what was done.

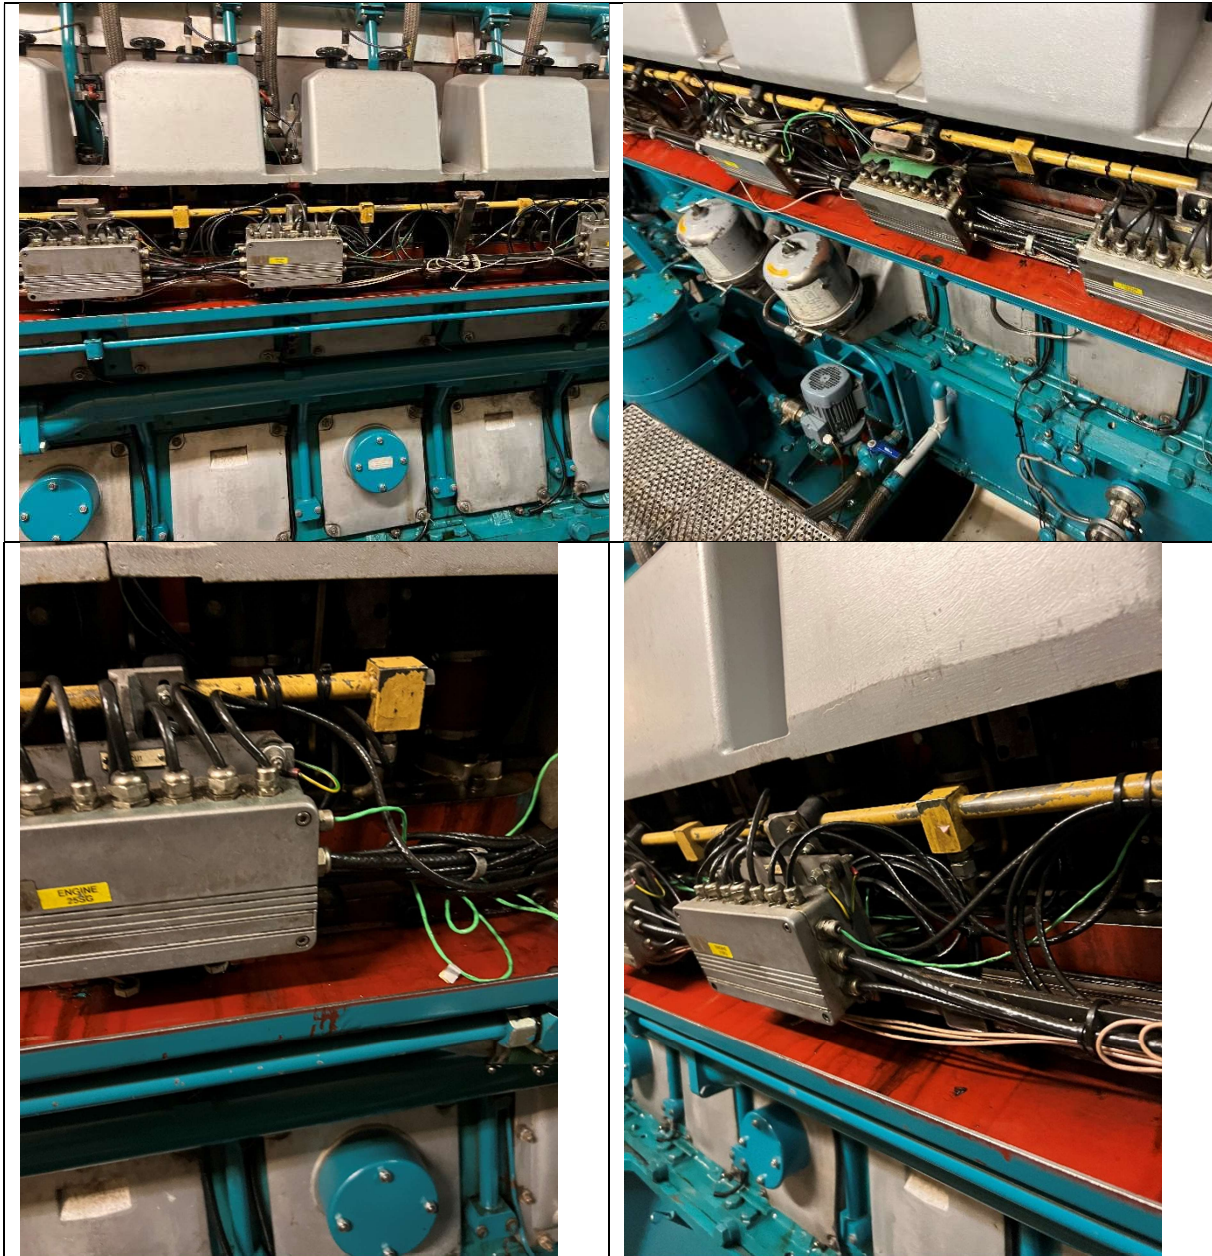
2.4 Hotbox

Hot box on both A and B- bank were inspected. Condition of pipings and visable parts was found in good condition. Minor oil leakages located on and next to valve lifter brackets.

3.1 Seal minor leakages where found.

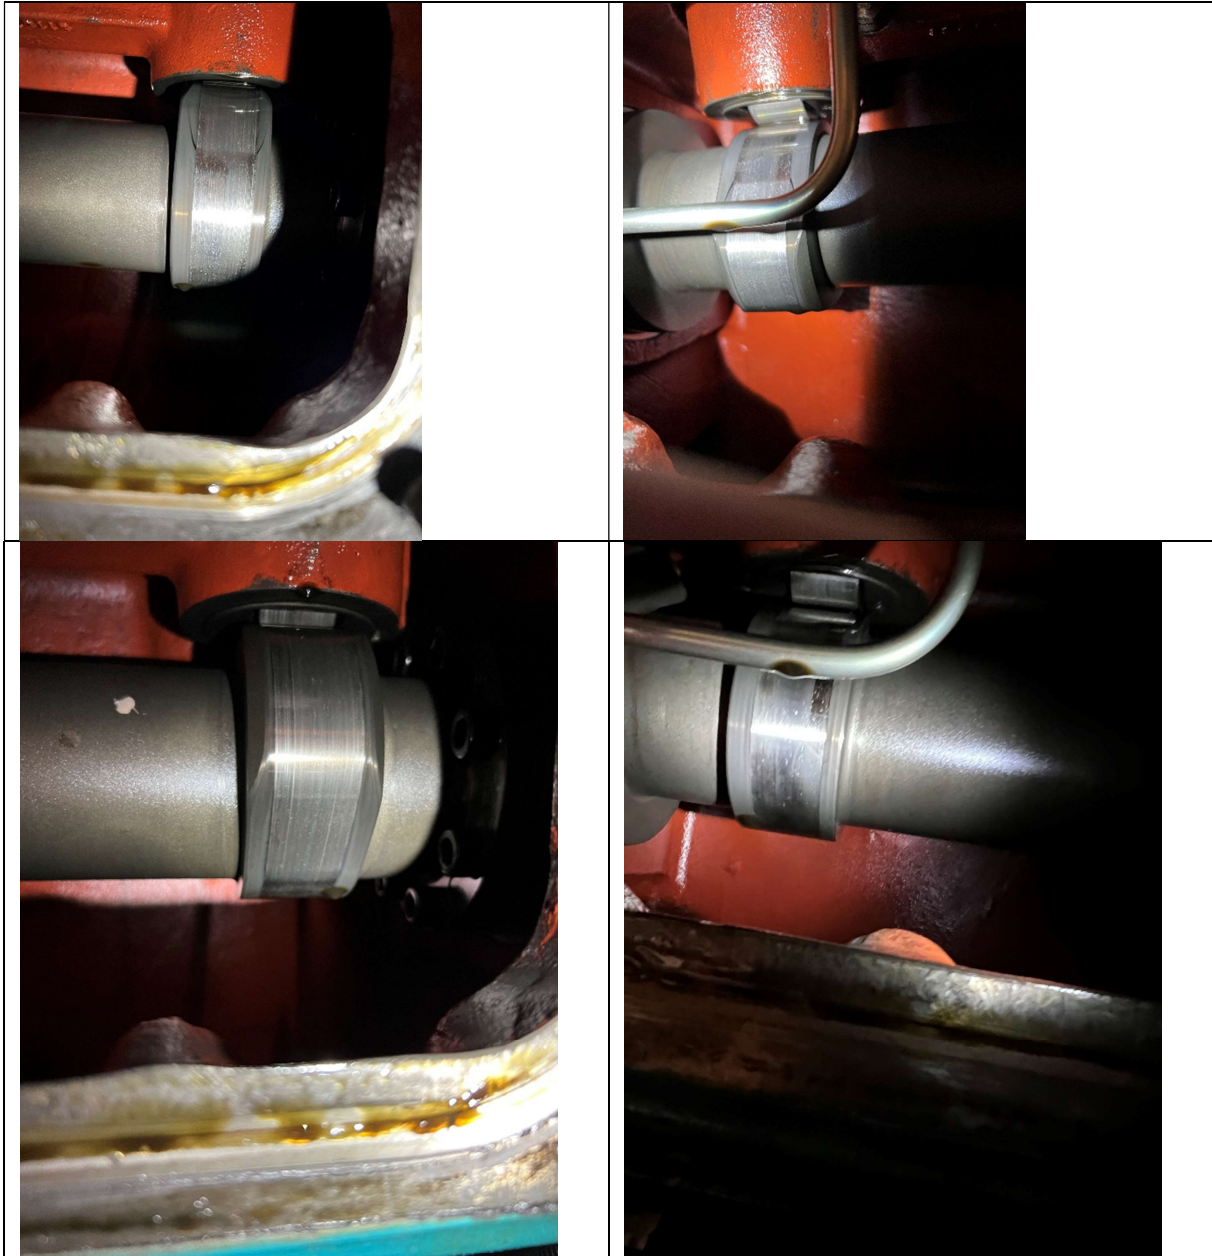
2.5 Camshafts

Camshaft sections were inspected and minor wear and pitting were found on both inlet and exhaust cam nocks.

No problem for further operation but recommend inspecting regularly on a 2 500 hrs. basis.

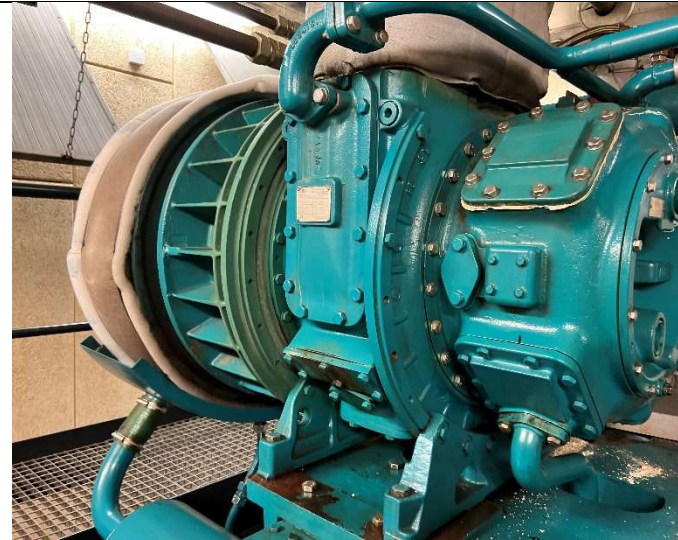
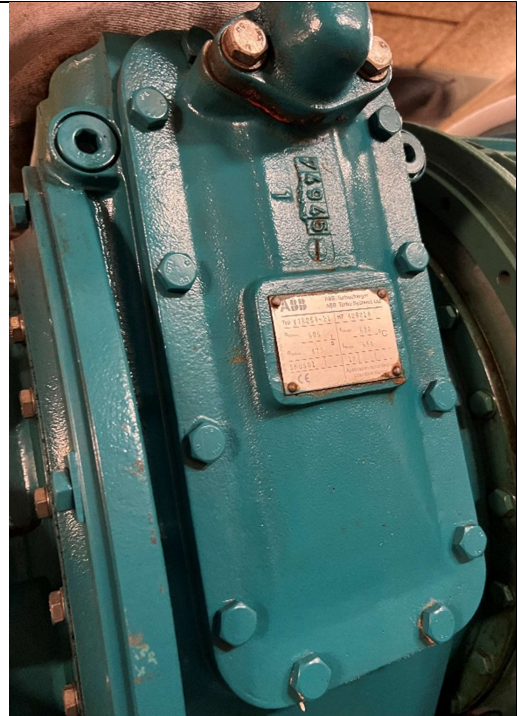
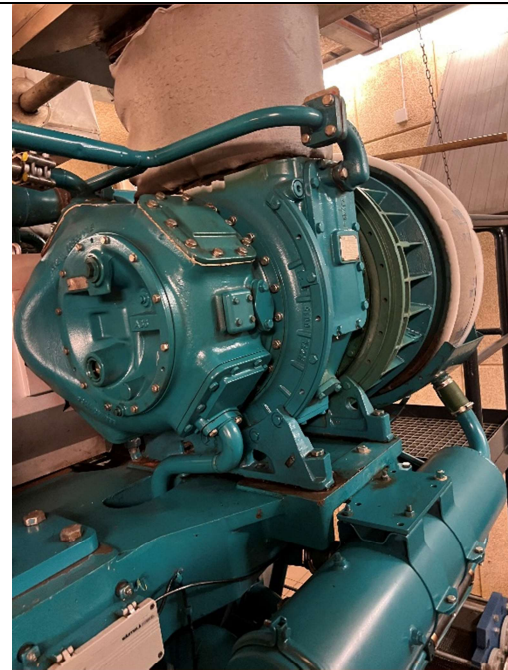
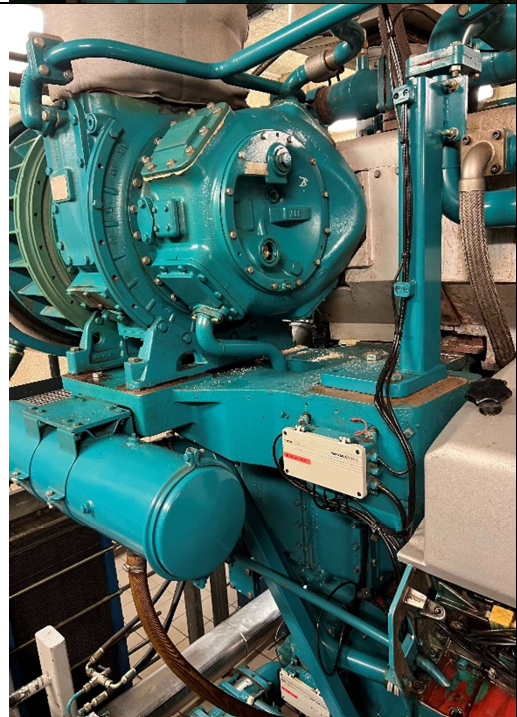
2.6 Turbochargers

Turbochargers were visually inspected from outside and was found intact without damages. Acc. to report from 50 000 service both turbochargers were cleaned, inspected and bearings renewed. Recommend to inspect and clean turbochargers and renew bearings before put back in operation since they reached recommended service hours already.

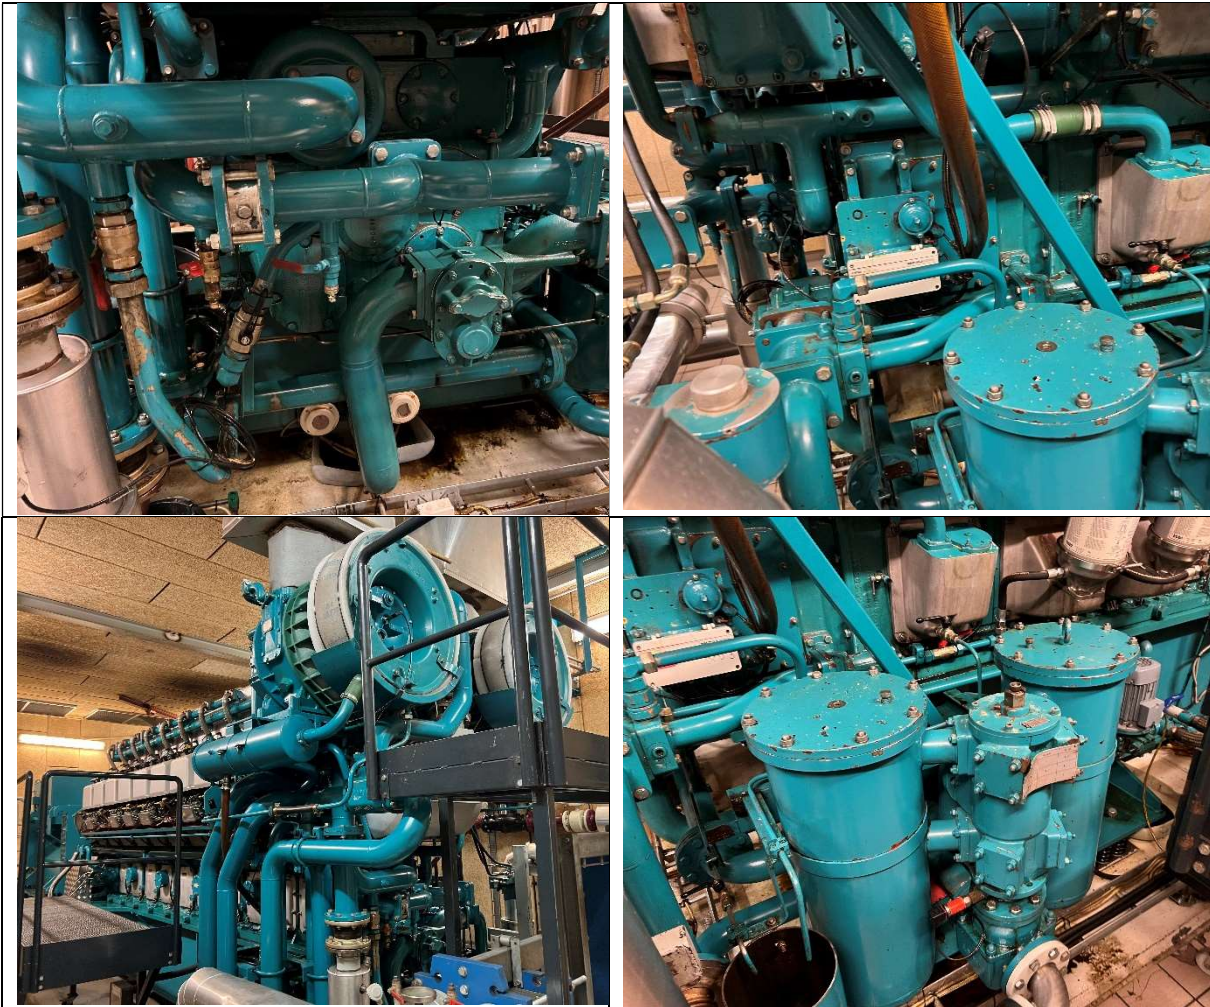
2.7 Fore end with engine driven pumps and filters etc.

Lubricating oil pumps – No leakages or discrepancies were noted.

Freshwater pump - No leakages or discrepancies were noted.

Thermostatic valve housing – Good visible condition.

Charge air cooler – Visible outer surfaces was in good condition.

Lube oil filter unit – Good condition.

Pipe connections, fore end – Several leakages in connections noted. Recommend renewing seals.

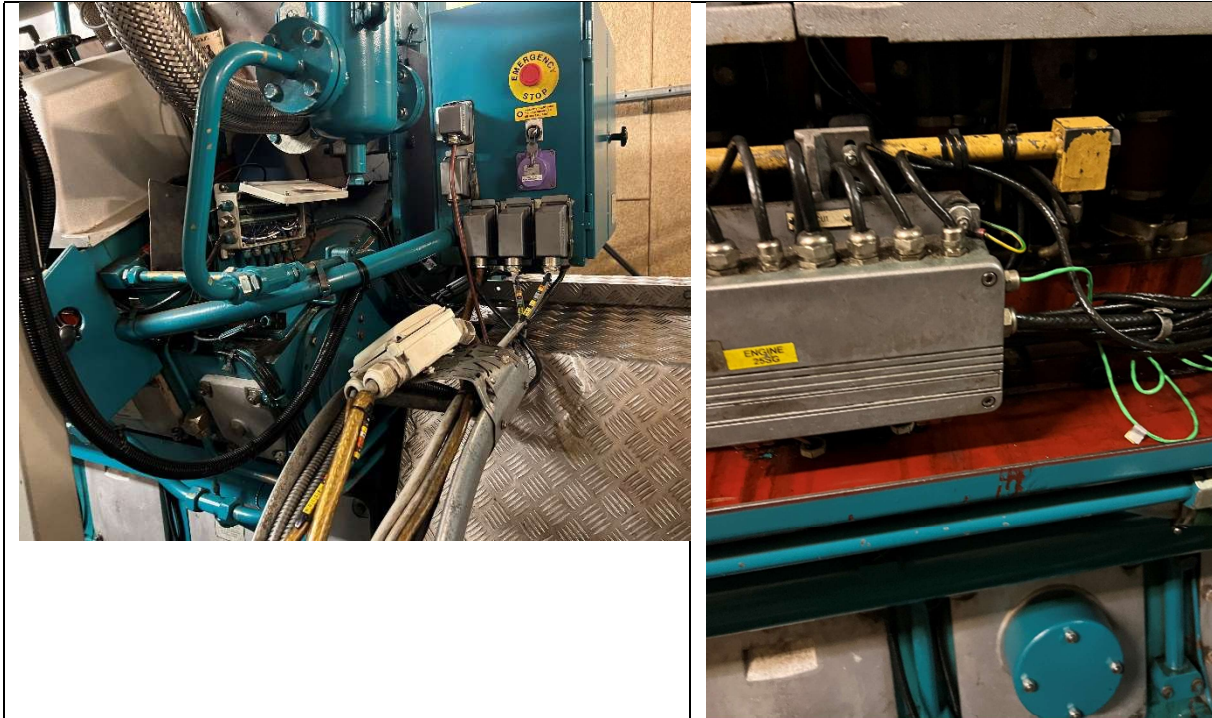
2.8 Electrical equipment

Electrical equipment was visually intact and was working properly when engine was stopped according to staff on site. MCU Processor card was renewed in 2018 acc. to report and invoice from Wärtsilä DK.
