Inspection Report of
Waukesha Gas gen-set Model L36 GLD 12 Cylinder

Manufacturing date: 1998
Operating hours: N/A
Control System: N/A

Inspection includes cylinder heads and Chambers, Turbo chargers, Crankcase and Conrods.

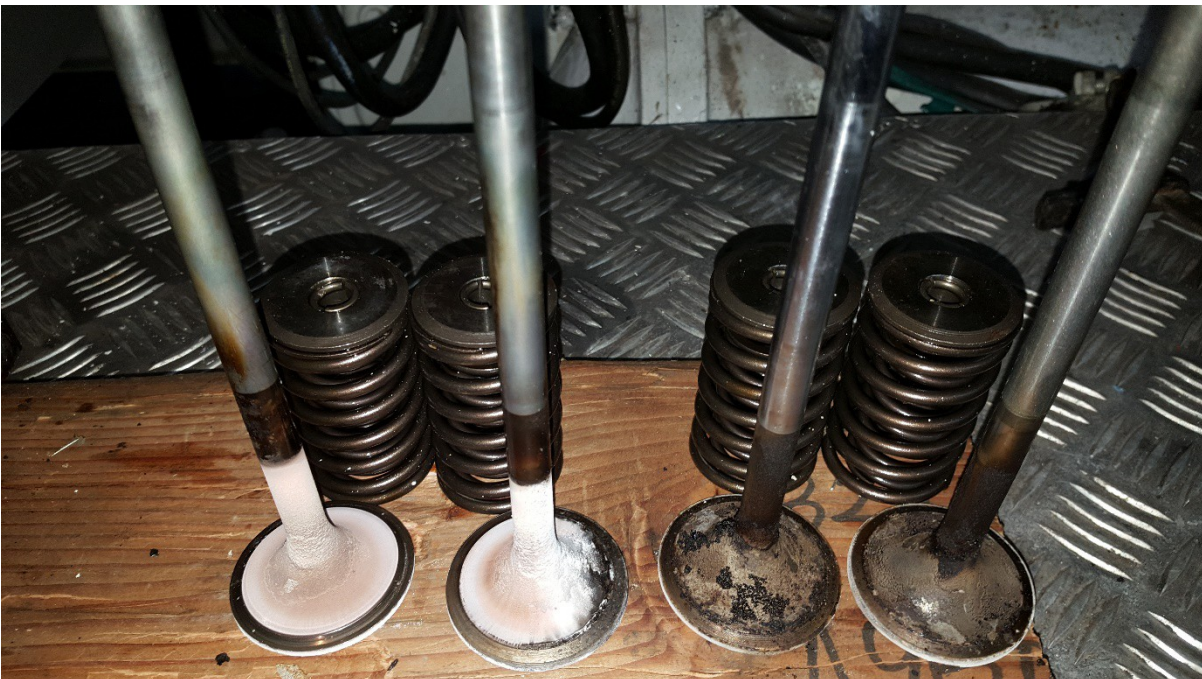
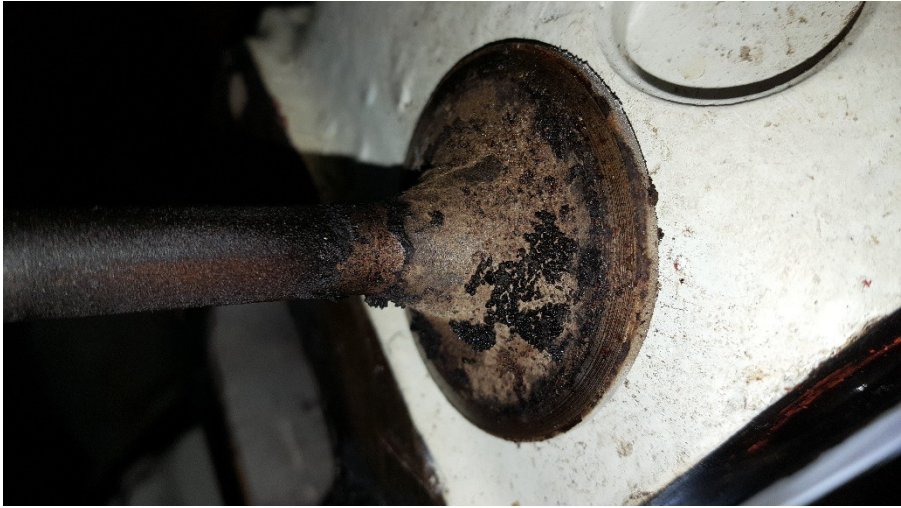
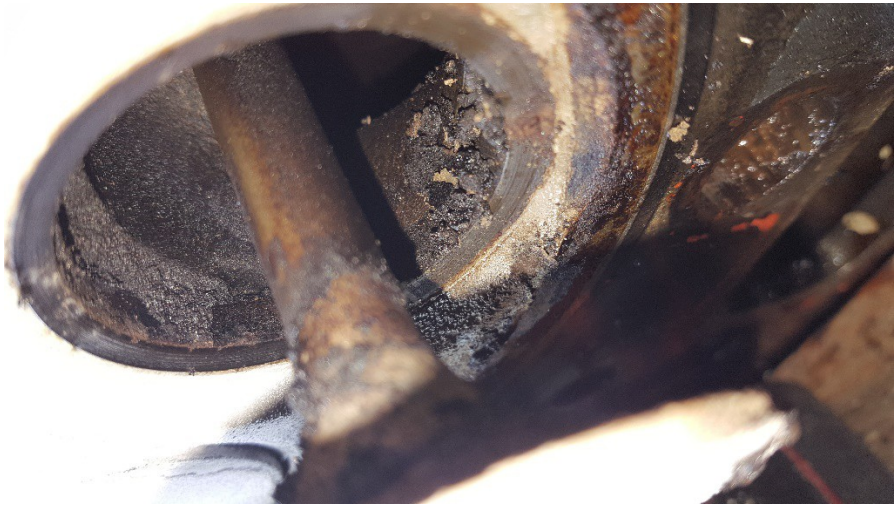
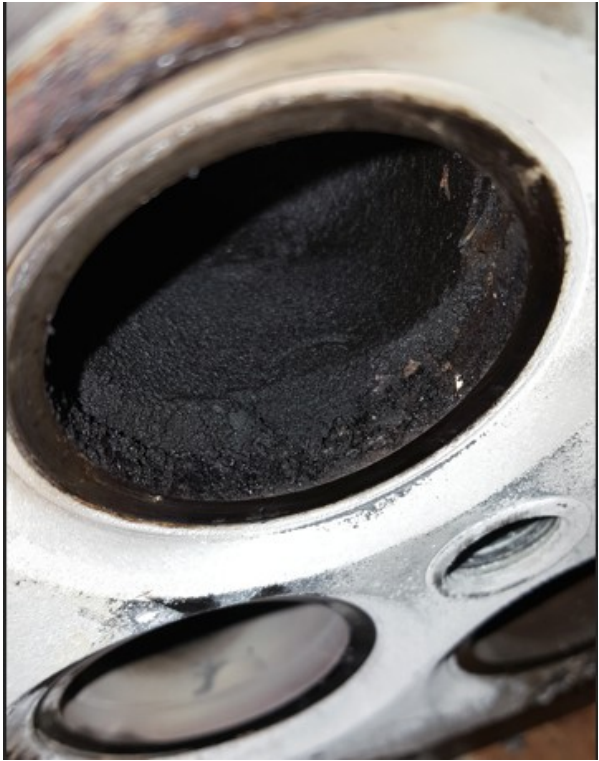
are looking good and show no crack and burning signs. Intake Valves have too much soot and combustion deposit between Guide and Seat which must be fully polished.

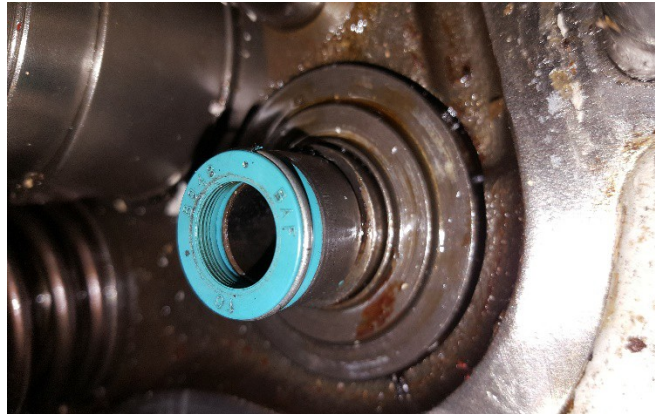
Valve seal oils on both exhaust valves are looking visually good and there is no trace of leakage on Valve stem but on Intake valves, that would be a potential for such deposit.

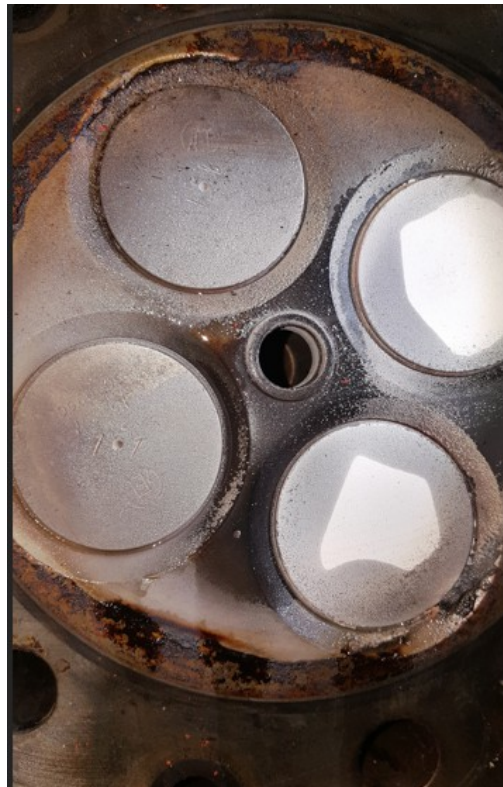
Sealing Test of Valves by diesel, shows leaking mostly by Intake valves. There is no sign of wearing or crack on valves and seats which seems a good sign to making valve sealing possible after refurbishing.

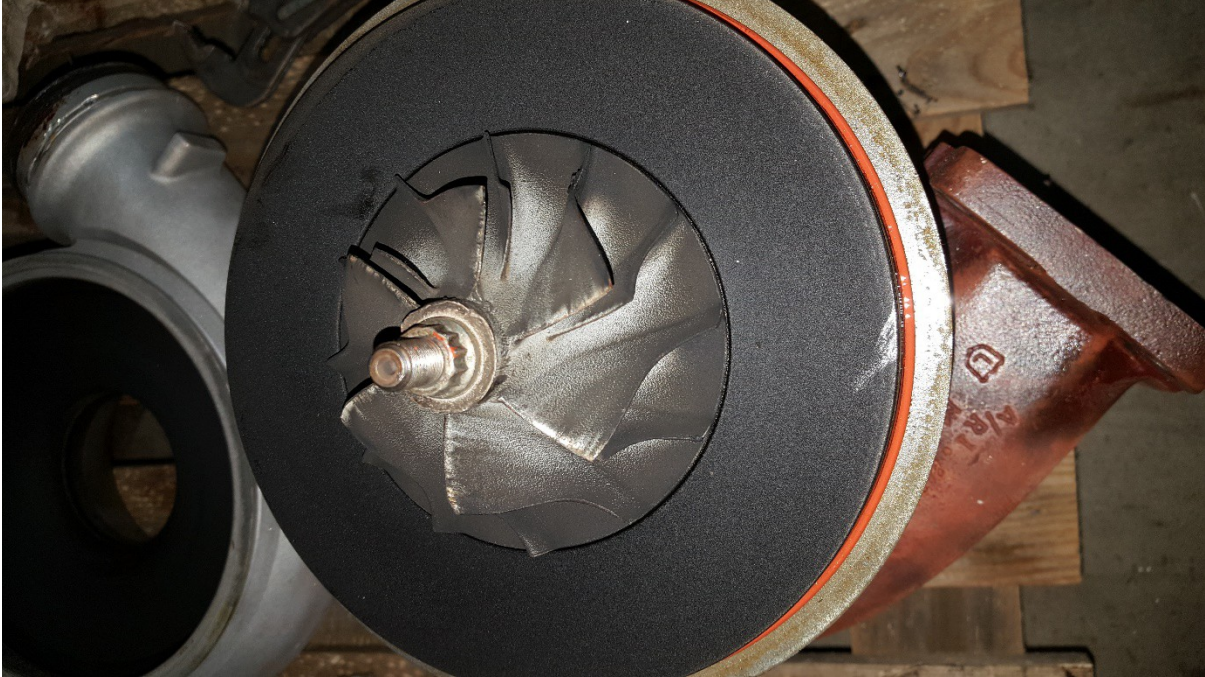
The Turbochargers have been inspected and checked. Oil cartridge on both of Turbochargers has over radial clearance and too much tilting which probably has caused oil leakage inside of after-cooler. Inside of the after-cooler and Air intake manifold are oily and that likely approves such defect on Turbo's Oil cartridge. Black soot on compressor side of the Turbochargers have been probably created by same defect.

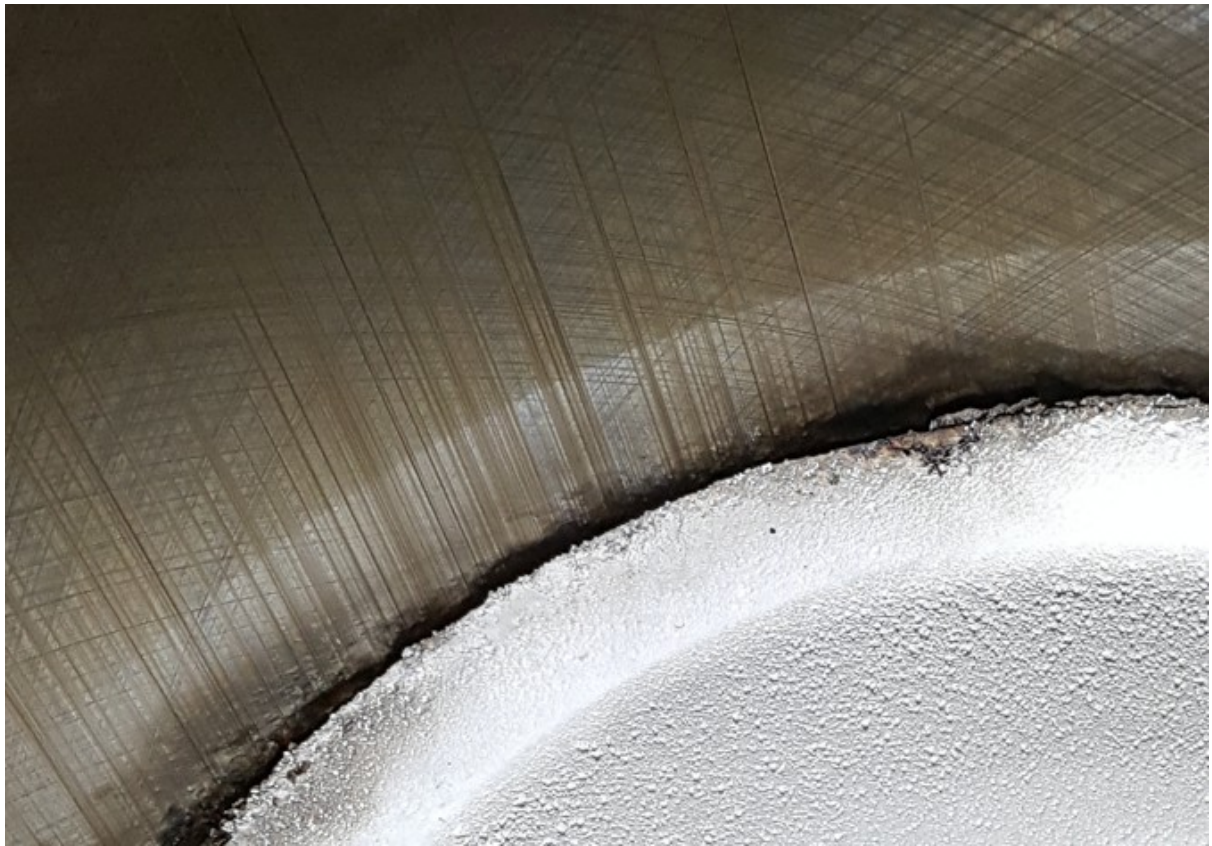
The Liners on some cylinders have Significant scratches which has probably caused by Piston rings friction. Generally, that could not affect engines operation seriously since we have not only found any trace of oil burning on surface of the cylinder heads but also exhaust valves. They have good condition of honing in most of the parts but that would be recommended to be observed for right time elimination.

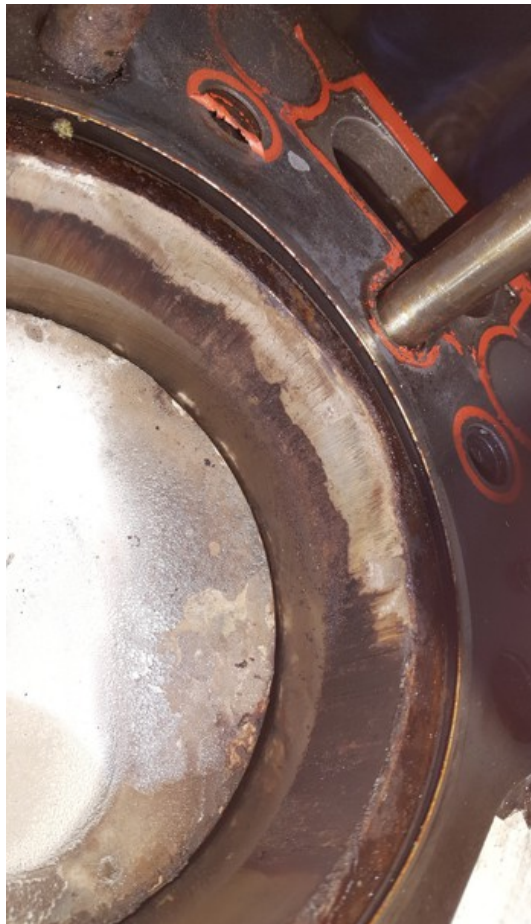
Scraper rings around top of the Liners are complete burned and exhausted and it is strongly recommended to replace them.
