Assessment of a gas engine system for

Kandlin Stromerzeuger-Ankauf GmbH, Körtener
Str. 13, 51465
Bergisch Gladbach

Tuesday, April 21, 2026 in 01616 Strehla, An der alten Leimfabrik 2. The CHP unit was housed in a warehouse.

Gas engine MDE 173 KW engine MAN E2876 LE701

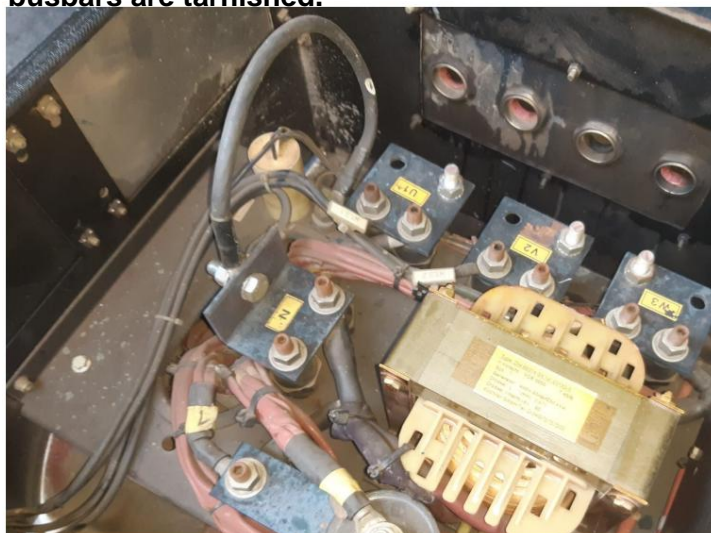
The mixture cooler is heavily soiled; oil and dirt are clearly visible in the register. Heavy deposits on pistons and valves, significant wear on the cylinder liners. The exhaust system and AWT are heavily contaminated with sulfur deposits. The generator should be repaired, as it is internally dirty and the copper busbars are tarnished.

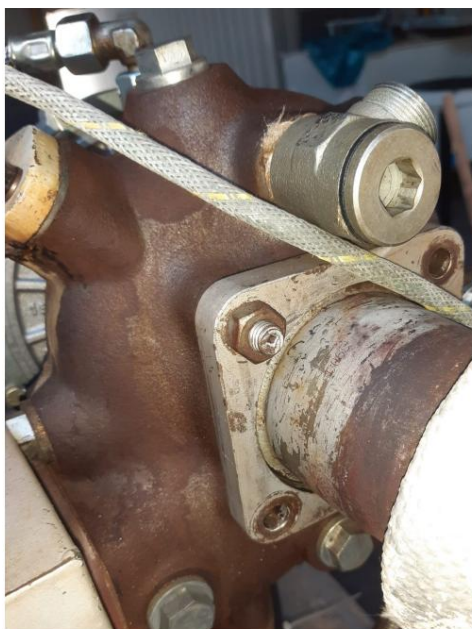
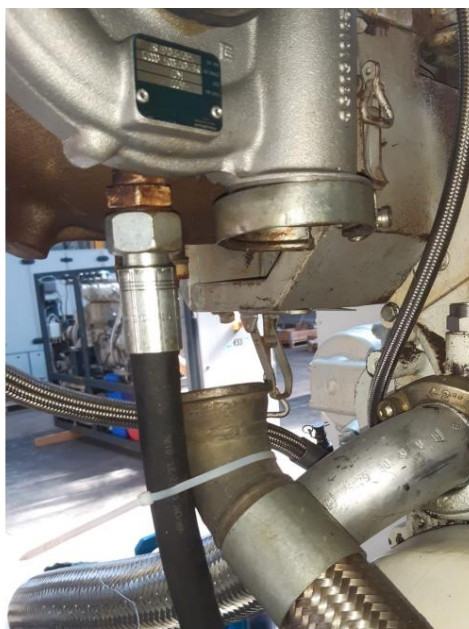
The exhaust gas turbocharger was visually inspected; the bearing clearance is correct.

The exhaust flange of the exhaust turbocharger is missing bolts for fastening.

Several screws are missing from the engine, and the receiver piping is not connected. The crankcase ventilation is only held in place by one screw.

After the defects have been rectified, the CHP unit should be operational again and the CHP unit should generally be able to be operated.
