# BHKW Service Deutschland GmbH

## Assessment of a gas engine system for

Tuesday, April 21, 2026 in 01616 Strehla, An der alten Leimfabrik 2. The CHP unit was housed in a warehouse.

2G Agenitor 206 Serial number MH1011B-EGLB-220094

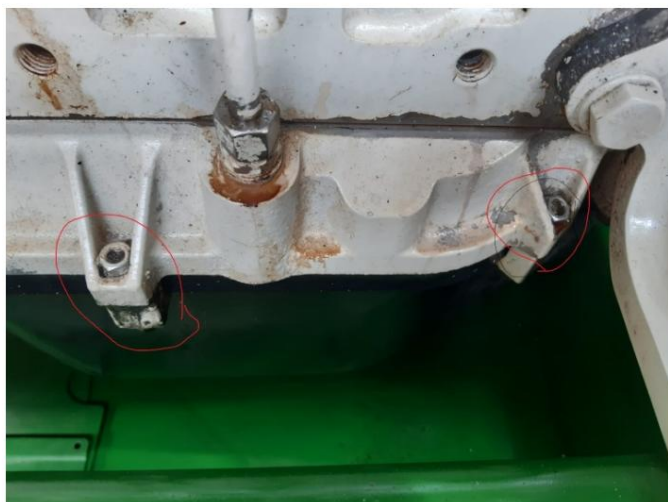
Clutch of motor/generator defective, extremely cracked

Crankcase-oil pan connecting plate (yoke) all threads stripped

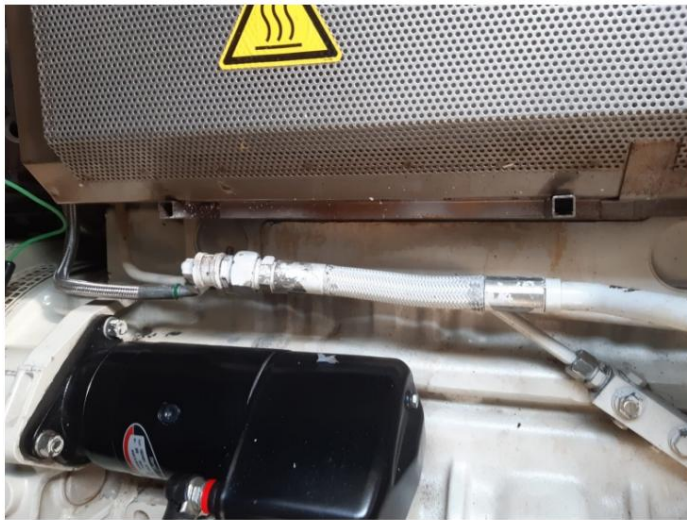
**Exhaust manifold heat shield not attached**

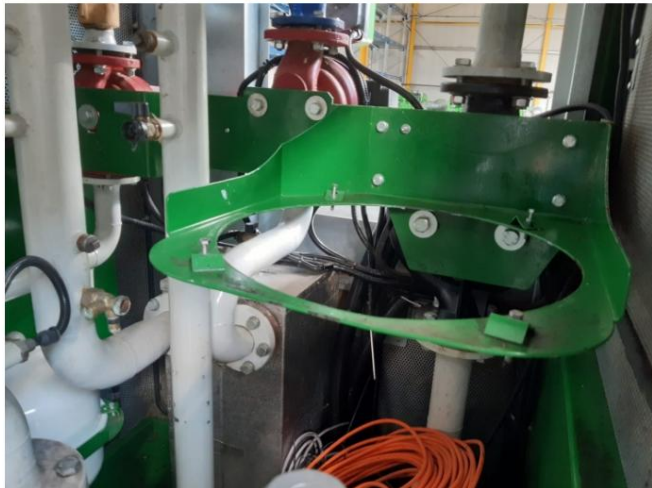
**The expansion vessel for the engine cooling circuit is missing, as are the connecting pipe and the cap valve.**

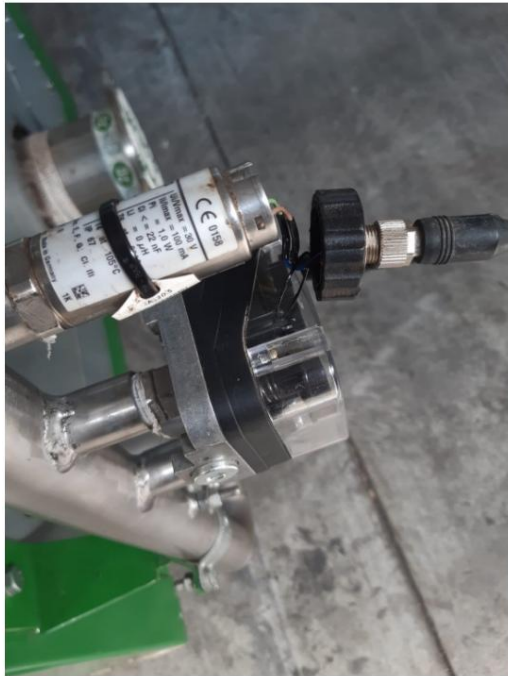
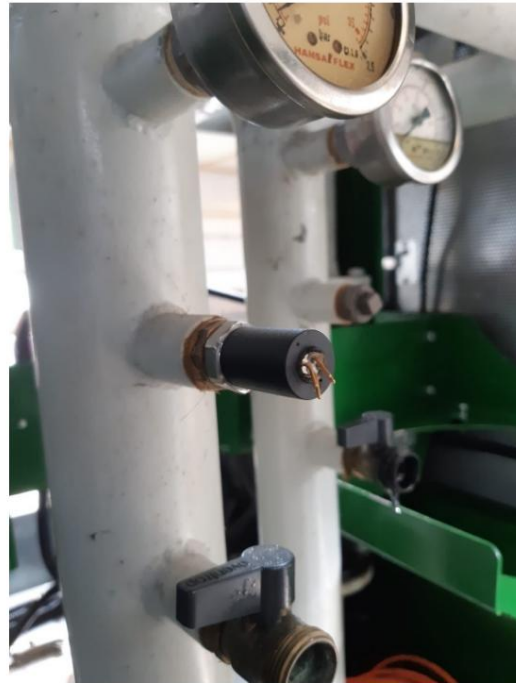
Gas pressure sensor in gas line defective, coolant pressure sensor in engine cooling circuits defective.
