## Assessment of a gas engine system for

Kandlin Stromerzeuger-Ankauf GmbH,  
Kürtener Str. 13,  
51465 Bergisch Gladbach

## Designation of the plant

Sokratherm GG 402 H with 17772 operating hours.

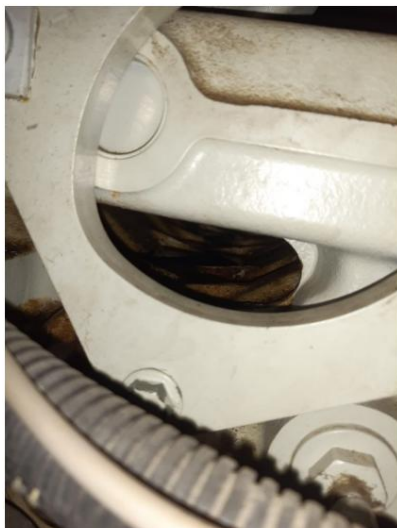
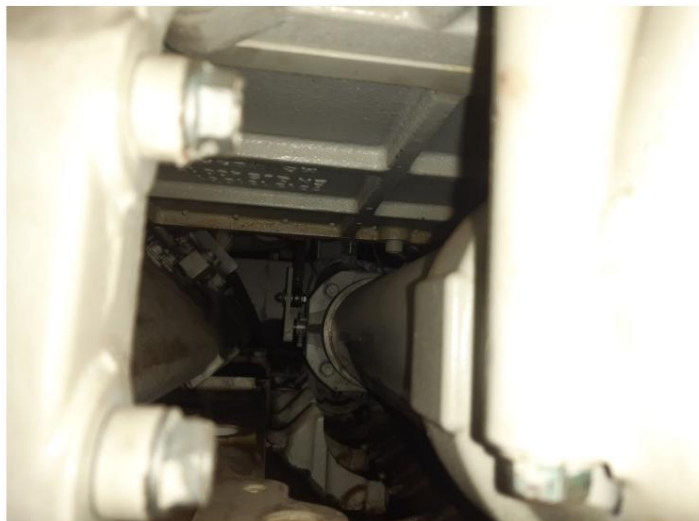
Oil leak from mixture cooler to charge air line: Seal in the lower area is leaking, resulting in oil in the V

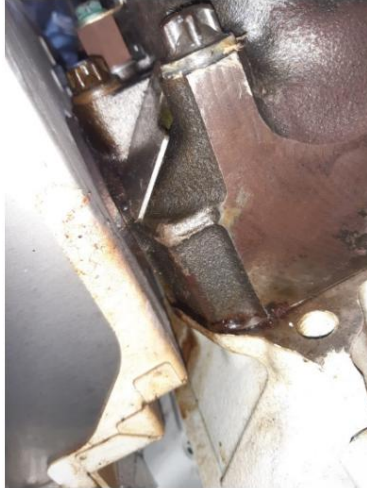
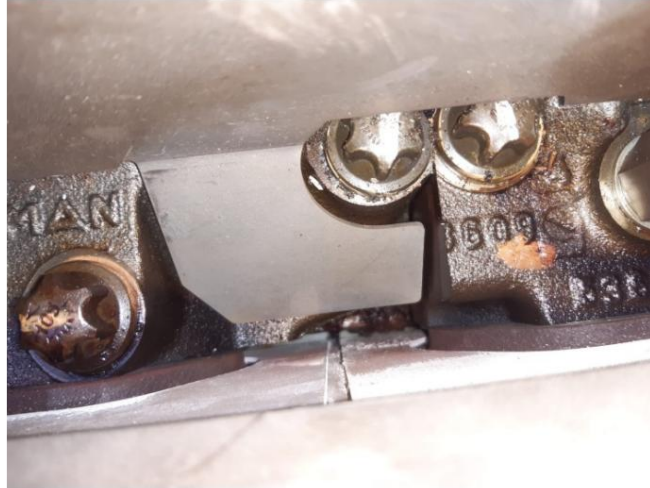
## Rubber coupling

porous, cylinder head gasket 1, 2, 3, 4, 7, and 8 leaking – water loss to the outside.

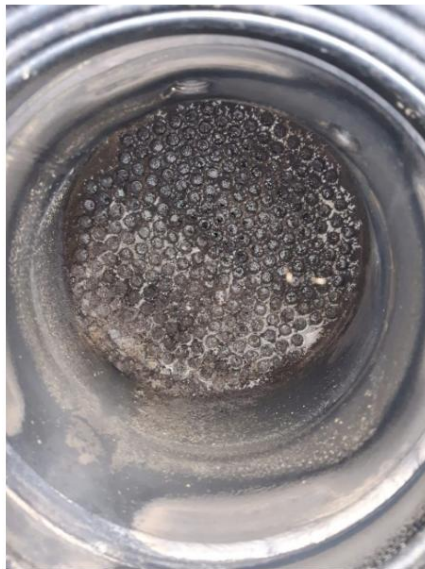
Exhaust gas heat exchanger extremely dirty.
