Assessment of a gas engine system for

Kandlin Stromerzeuger-Ankauf GmbH,
Kürtener Str. 13,
51465 Bergisch Gladbach

Tuesday, April 21, 2026 in 01616 Strehla, An der alten Leimfabrik 2. The CHP unit was housed in a warehouse.

Viessmann Vito Block 200 MAN E 0836 E302 Serial number: 10235035123502

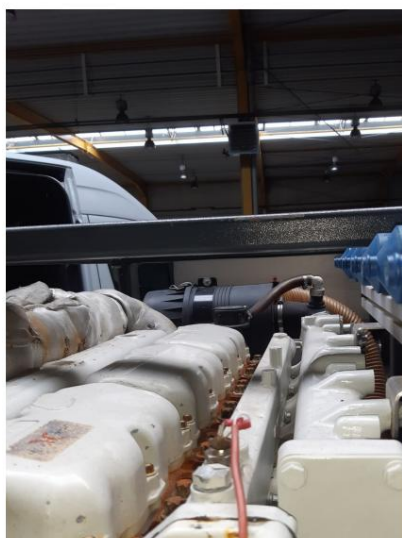
Visual inspection of the cylinders revealed cylinder liner wear, including a bare metal finish on the liners and surface rust. Heavy deposits are visible on the pistons and valves.

Once the defects have been rectified, the CHP unit can be put back into operation. Whether further defects will arise during commissioning can only be determined at that time.
