Assessment of a gas engine system for

Kandlin Stromerzeuger-Ankauf GmbH,
Kürtener Str. 13,
51465 Bergisch Gladbach

Designation of the plant

Viessmann Vito Block 200 MAN E 0836 E302 Serial number: 10236355043625

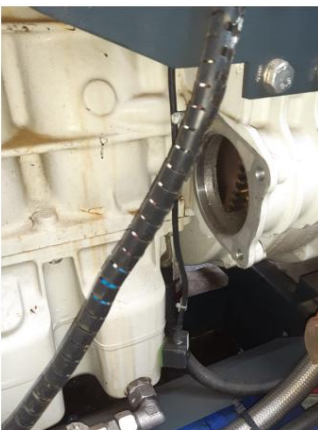
Ignition leads are missing

Starter motor missing

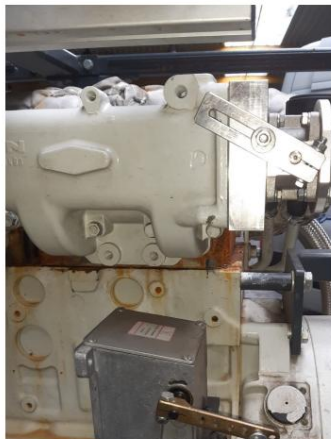
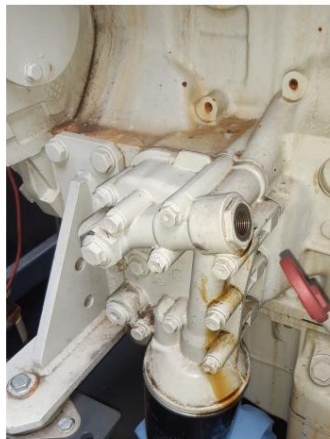
Throttle linkage missing, oil pressure switch missing

Heavy deposits on pistons and valves

Rust deposits in cylinder liners, combustion chambers covered with rust

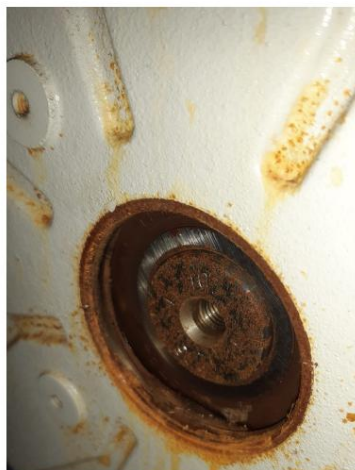
The generator bearing should be replaced (rust and hardened grease are visible on the bearing).

Once the defects have been rectified, the CHP unit can be put back into operation. Whether further defects will arise during commissioning can only be determined at that time.
