Assessment of a gas engine system for

Designation of the plant

Buderus 150 kW E2876 E312 Engine number 29839768153972

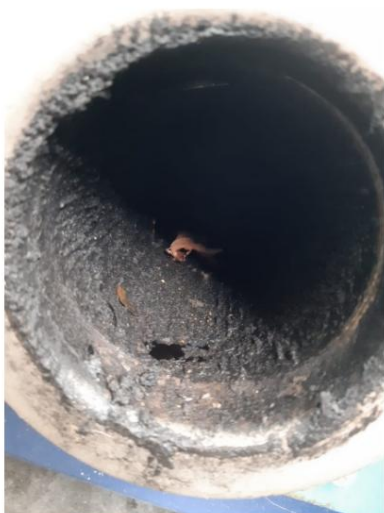
Cylinder liners show increased wear; pistons and cylinder heads with heavy deposits; engine has not yet been overhauled; clutch, engine, generator

The starter motor should be replaced (exterior impact marks).
Exhaust system and exhaust heat exchanger extremely dirty and sooty

The exhaust gas heat exchanger and the exhaust gas line must be cleaned before commissioning.

The plant could generally be operated, however, the combustion chambers will require repairs in the near future. The plant is in urgent need of an overhaul.
